1050 Acacia, Montara

Building Height Calculation
 Revised 9/24/07 Prepared by: RC

EXHIBIT H-2
 (rev 4)

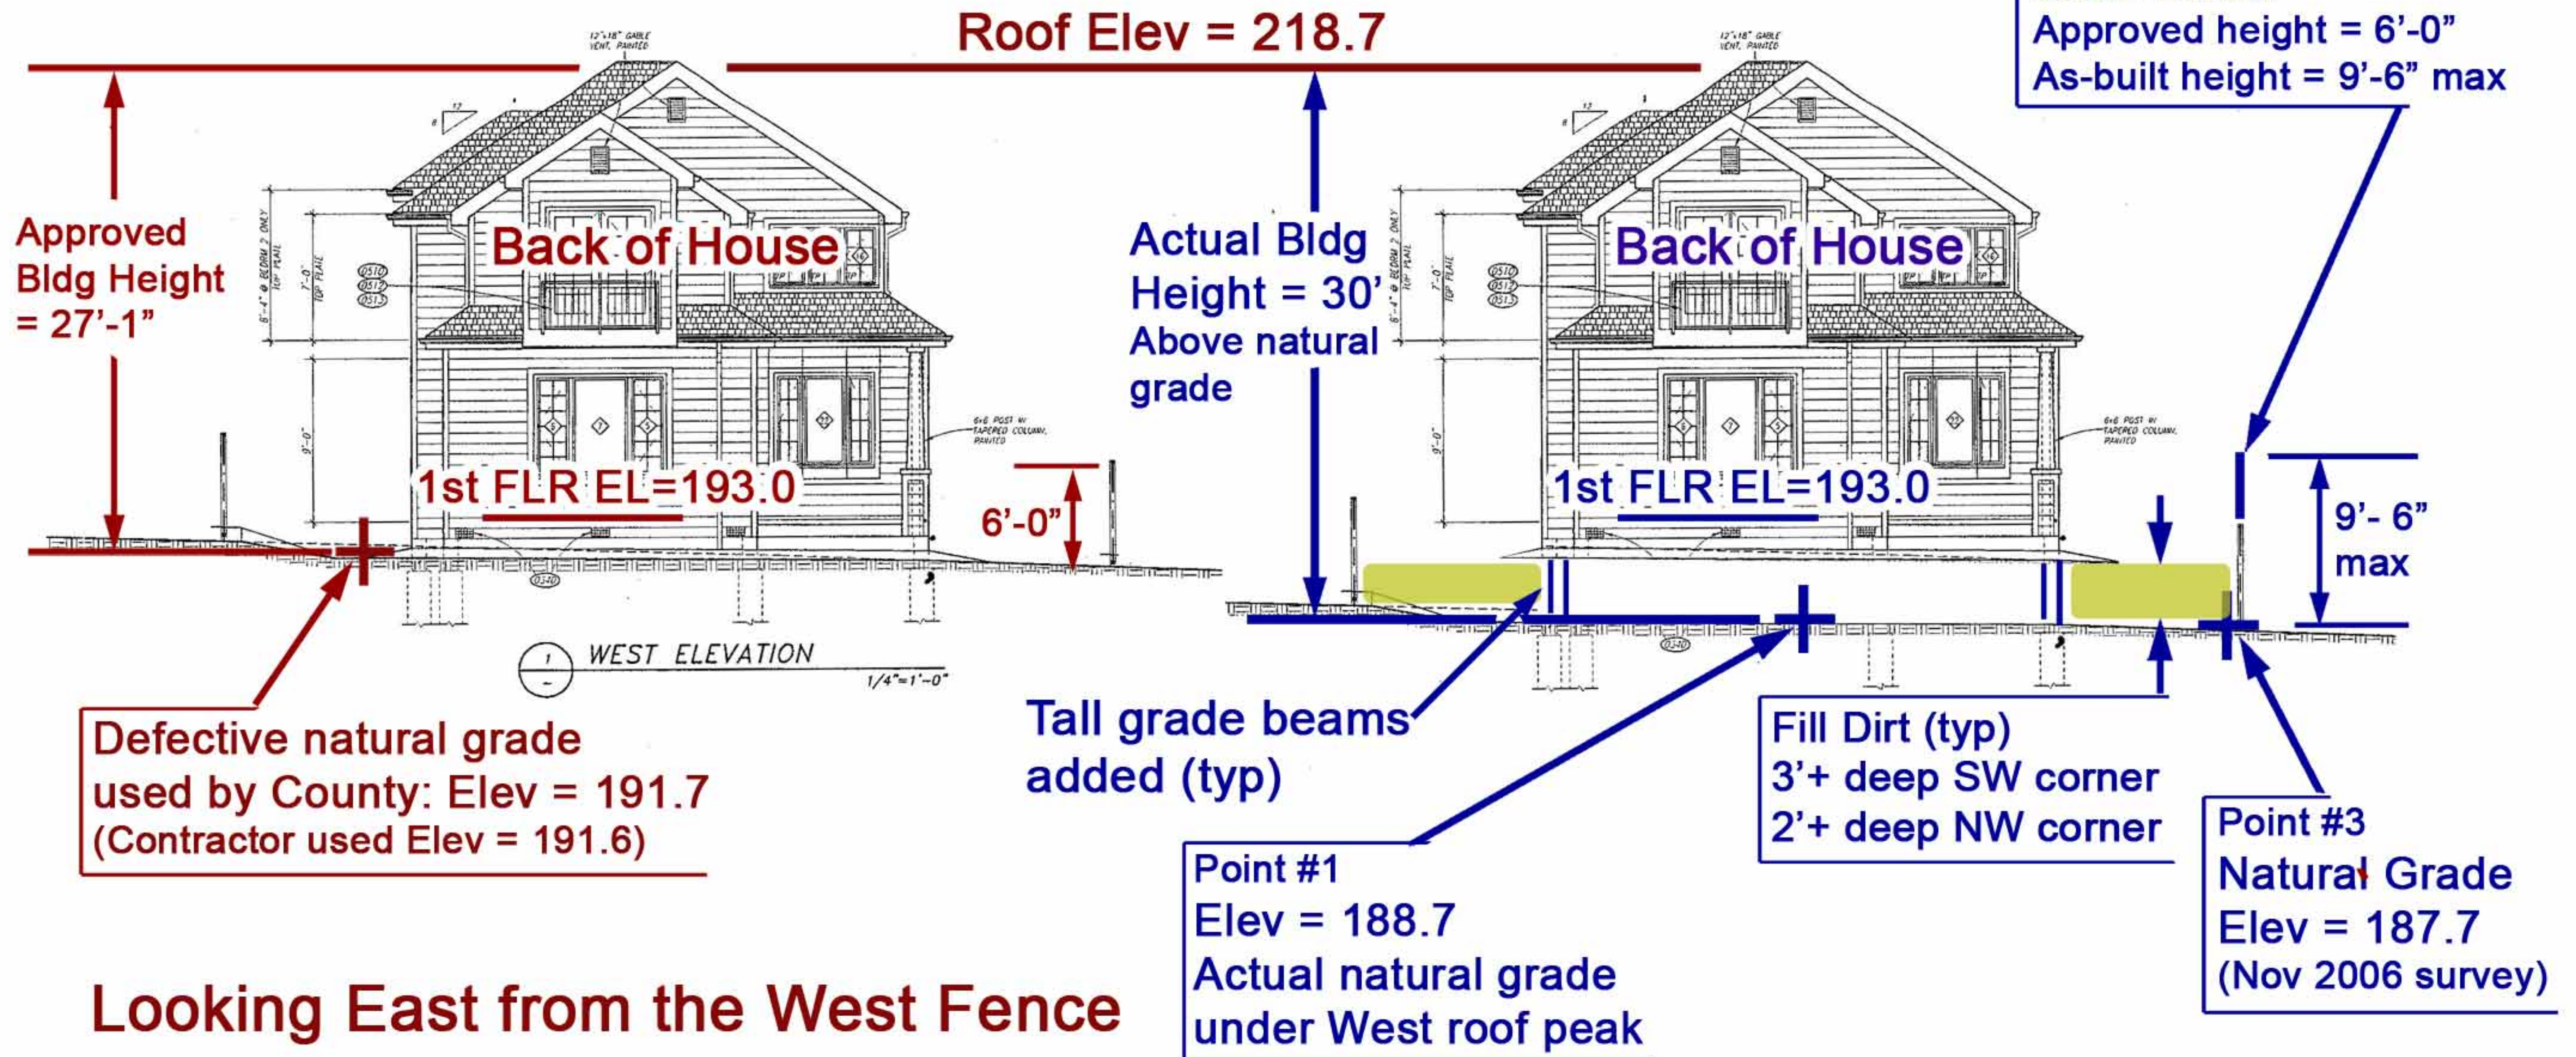
Looking East from the West Fence

Plans approved by the CDRC in Nov 2005 show the following: 1) The ground elevations much higher than actual - the error is up to about 3' at the west end of the property (i.e. the contours on the submitted plans were defective). 2) The 1st floor about 2' above the ground on the west end of the house. 3) No fill dirt around the house except for a few inches around the foundation. 4) House height of 27'-1" (so 27'-1" is the approved maximum height above 'natural grade'). 5) A 6' high fence on the South side with no fill dirt next to the fence.

Due to the defective elevations used on the design plans the as-built 1st floor is about five feet above the actual original ground at the West end (not the approximate 2' shown on approved plans). To compensate for the actual ground level being lower than shown on the plans, the contractor built tall grade beams (foundation walls) and placed deep fill dirt around the foundation walls; depth of dirt fill is about 3' at the Southwest corner of the house.

The actual house height of approximately 30' (above natural grade) violates the max allowable height of 28' under Zoning Regulation 6300.2.6. The dirt fill violates Zoning Regulation 6300.2.6 and Grading Ordinance 8602. The as-built fence on the South boundary reaches a max height of 9'-6" - a violation of Zoning Regulation 6412 (max allowable fence height = 6'-0").
