1050 Acacia - Email #2 - Current Rear Patio Construction URGENT

Subject: 1050 Acacia - Current Rear Patio Construction

Subject: 1050 Acacia - Current walkway construction, Illegal fill, Drainage , Low wall

REFERENCE: APN # 036-121-410 Design Review File No. PLN 2005-00418 & Correspondence at <http://1050Acacia.info/select>

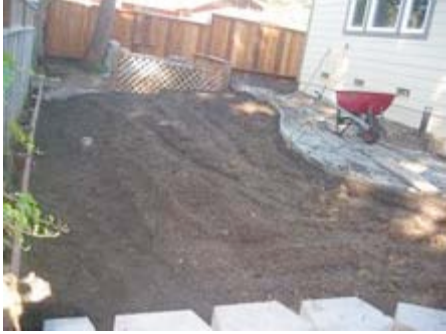
1050Acacia-070506-30__back-south-corner-retain-wall-at-tree_reduced.jpg
137K

LOW WALL AT WEST FENCE: The attached photos also show a low retaining wall (about 1' high) built about one foot away from the west fence (my fence). This structure is not shown on the approved design plans. This wall will trap material, fill up with dirt and debris, and lead to premature deterioration of the fence on my property line. This low wall also defeats the privacy feature of the fence. Please have this retaining wall removed from the site.

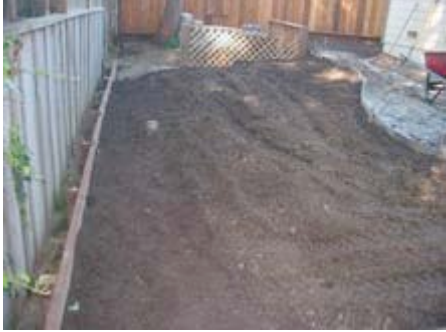
1050Acacia-070506-32__back-from-SW-corner_reduced.jpg
87K

CURRENT WALKWAY CONSTRUCTION: The Contractor at 1050 Acacia is preparing to construct a walkway at the rear of the structure on top of illegal dirt fill. Please see the attached photos which show the forms in place. The installation may be scheduled for today, May 14th (assumed material is concrete). I am unable to find any indication of this walkway on the approved design plans, therefore I believe this work is not approved by the County. Please have this walkway construction, and any further landscape work on this illegal dirt fill stopped immediately. It is not prudent to allow the Contractor to expend additional funds on work that will be removed when the County enforces the County Code.

ILLEGAL FILL DIRT: The dirt fill the walkway is being constructed atop was built in violation of zoning regulation 6300.2.6, and without a required grading permit (a grading ordinance violation). In addition the dirt fill is not shown on the approved design drawings; in fact the site plan specifically calls for no site grading except for minor adjustments needed for drainage around the house. For additional background information and documentation of notice provided to the County on this issue please refer to: <http://1050acacia.info/select>. This fill dirt must be removed prior to the County's acceptance of this project.
